Reviewing the Türkiye-Syria Earthquake

a Geo-Structural Engineering Perspective

Kristy Lo, Boya Yin and Ethan Zhang

23 March 2023

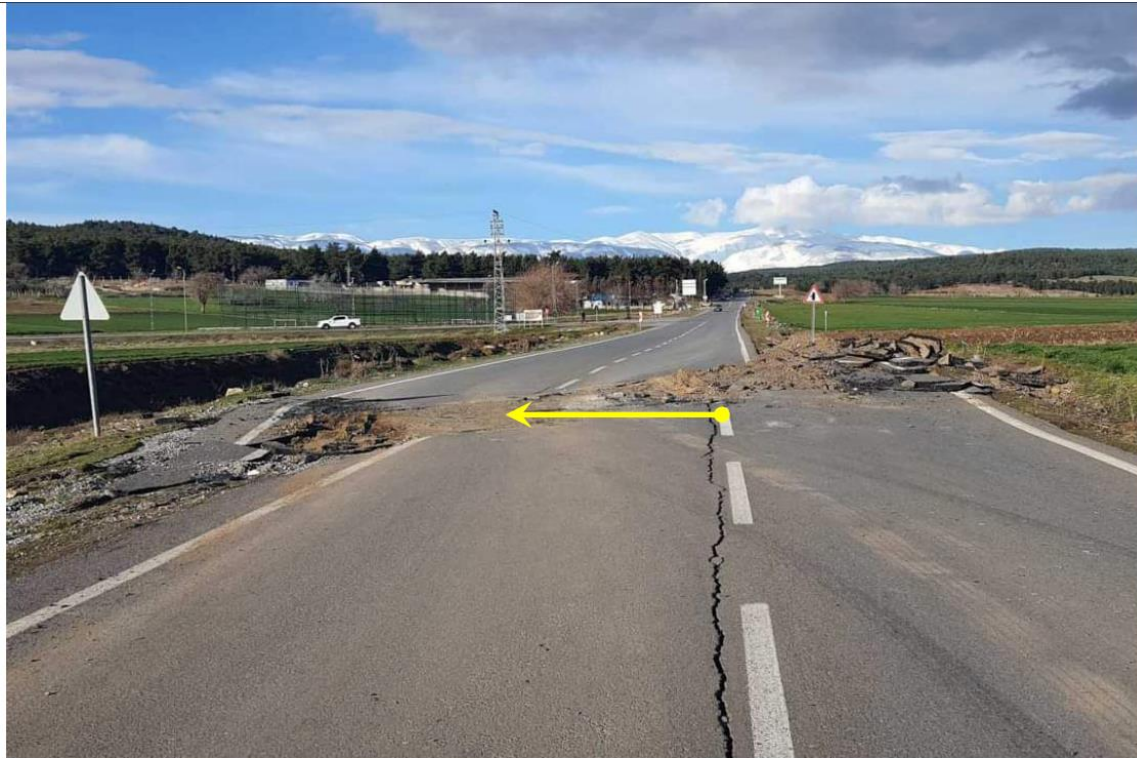
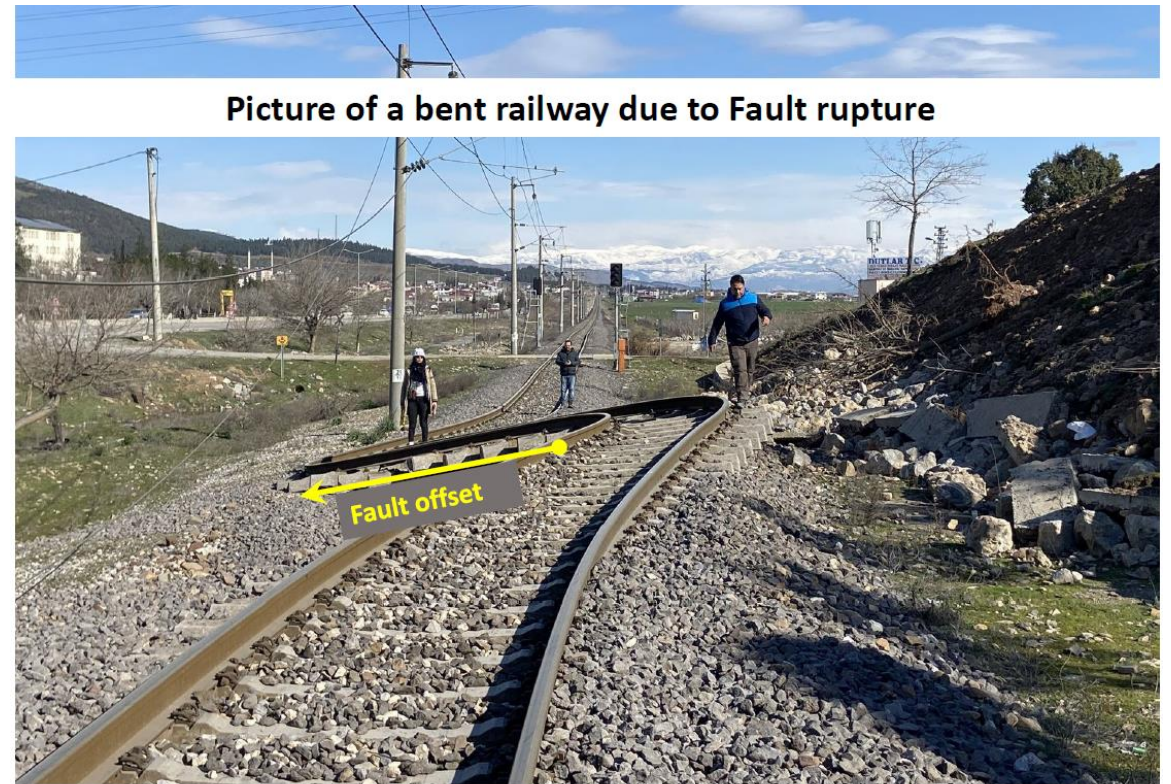
- Fault Rupture

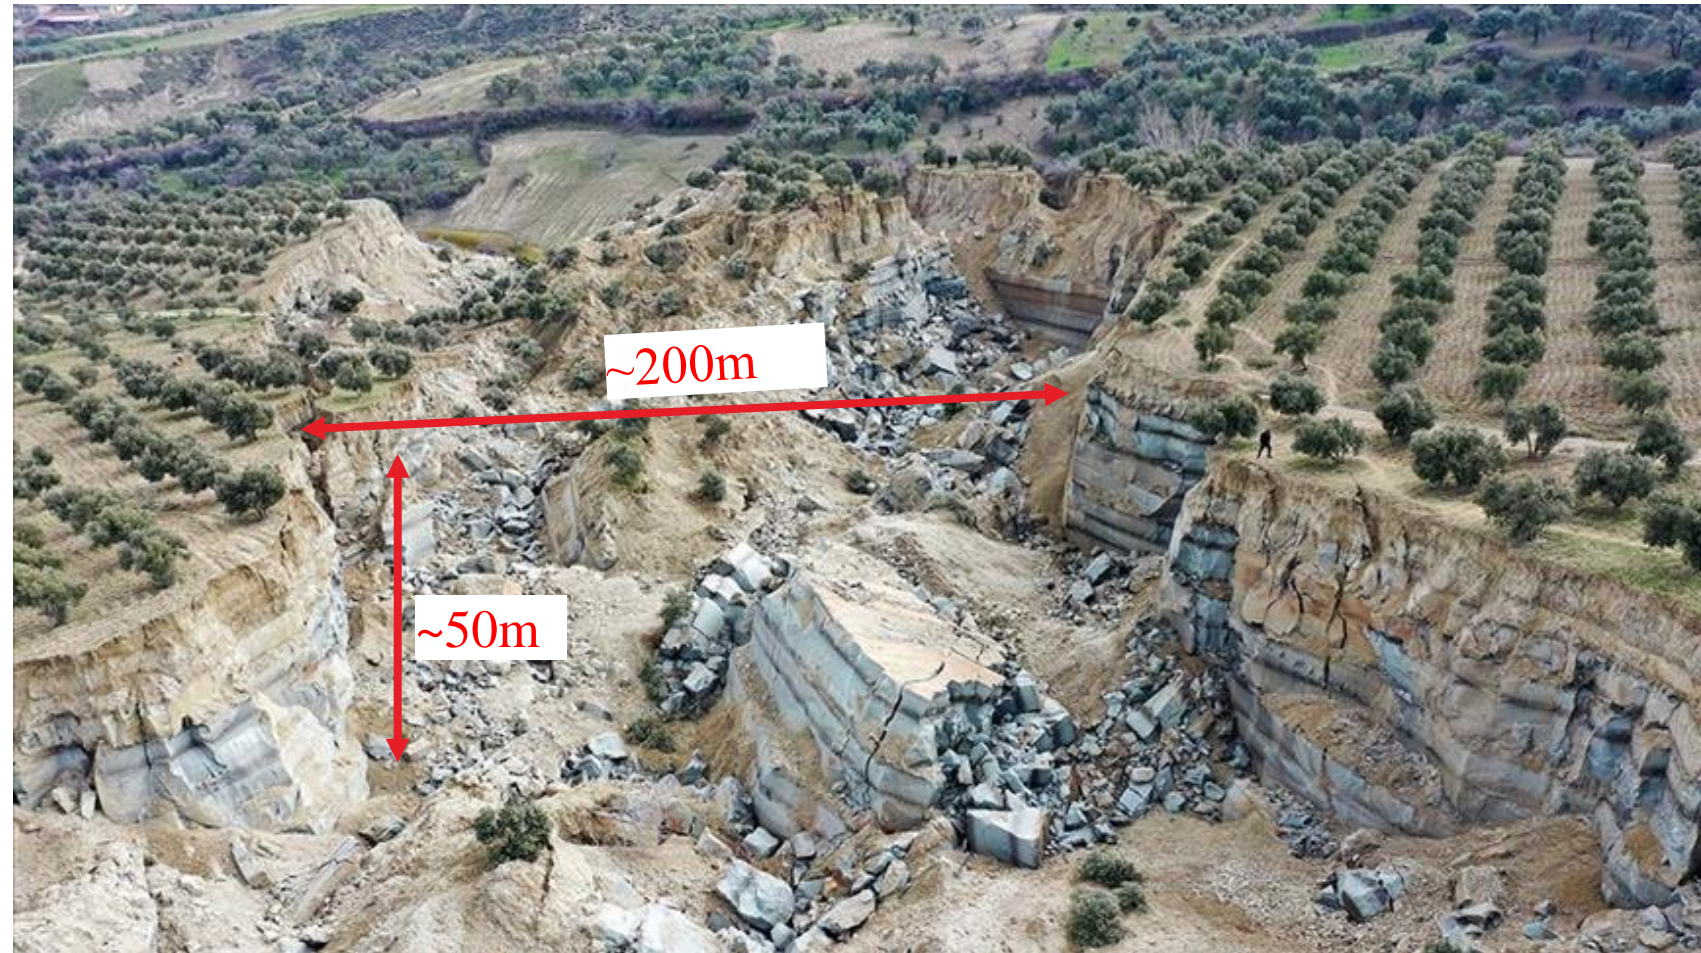
- Earth surface rupture
 - ✓ Width ~200m
 - ✓ Length ~400m
 - ✓ Depth ~ 50m

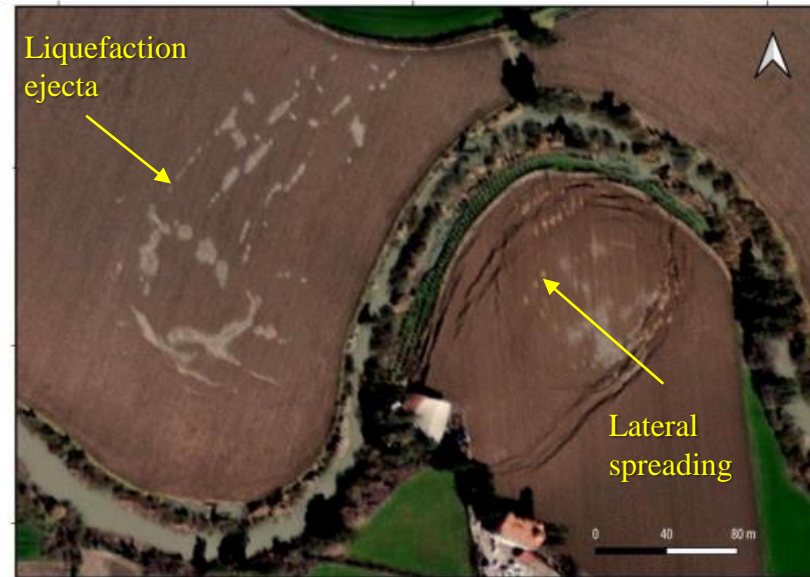
Mapping liquefaction and lateral spreading features in detail. An example from Orontes (Asi) river, north-east of Antakya.

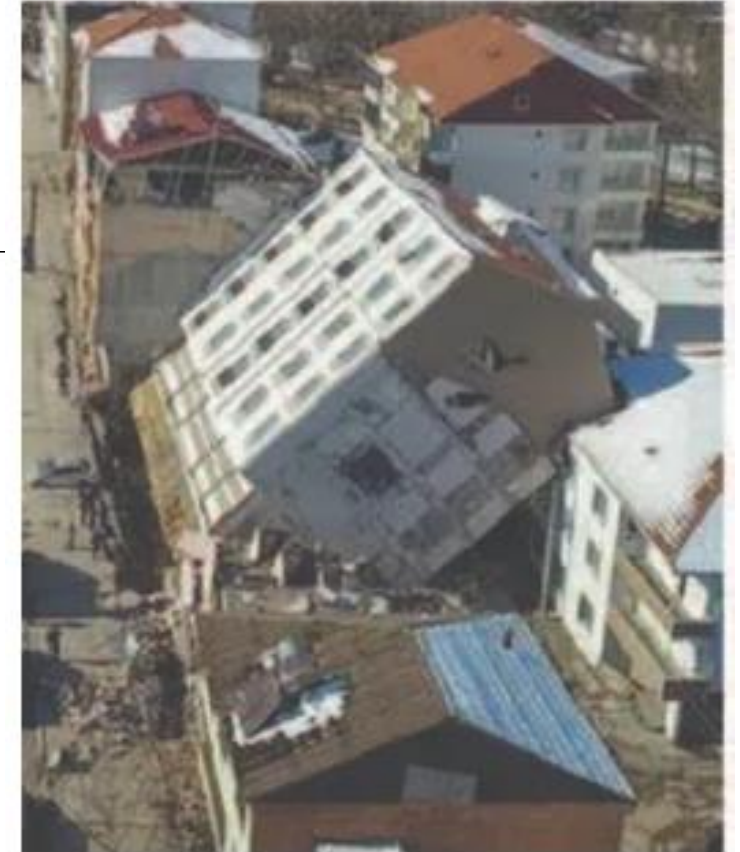
Effects of liquefaction, depicting a tilted building in the 2023 Turkey earthquake

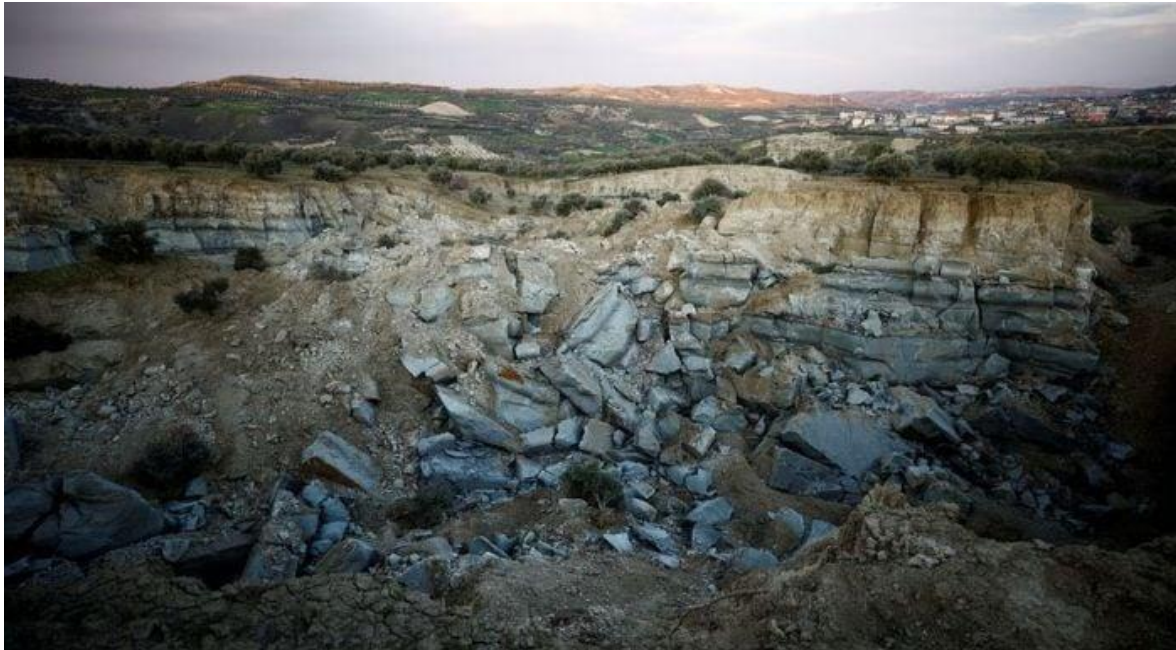
A view of terrain after a landslide that occurred in the aftermath of a deadly earthquake, in Tepehan, Turkey February 10, 2023.—
Reuters

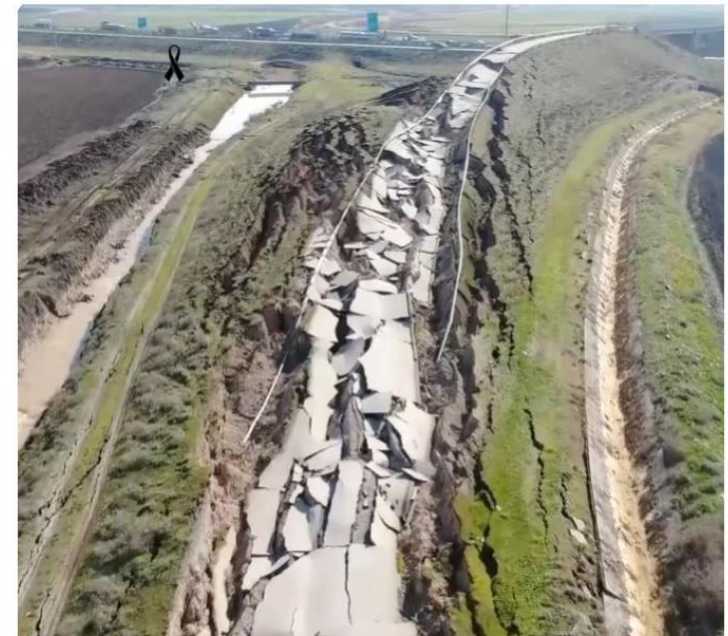
An extraordinary lateral spread in an embankment, triggered by the 2023 Turkey-Syria earthquakes. [Image from a video posted to Twitter by @Sabah.](#)

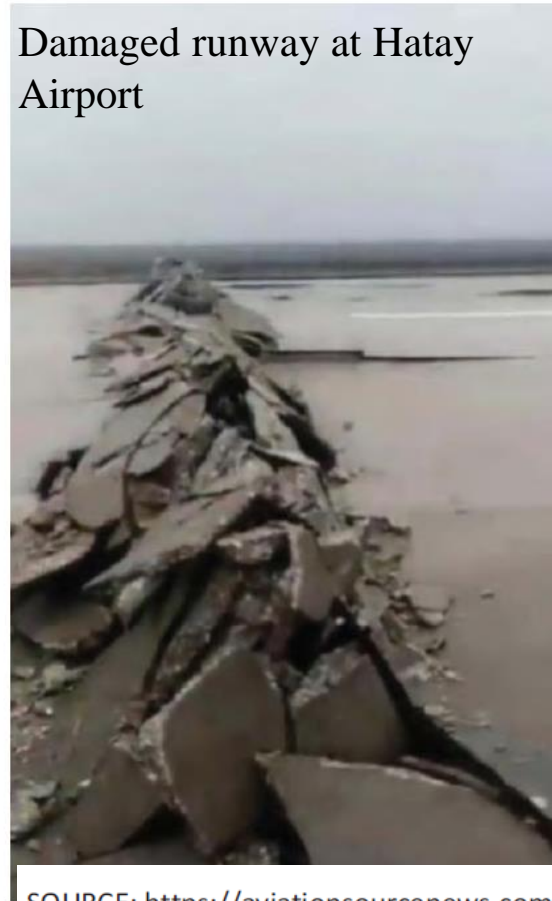
Damaged runway at Hatay Airport

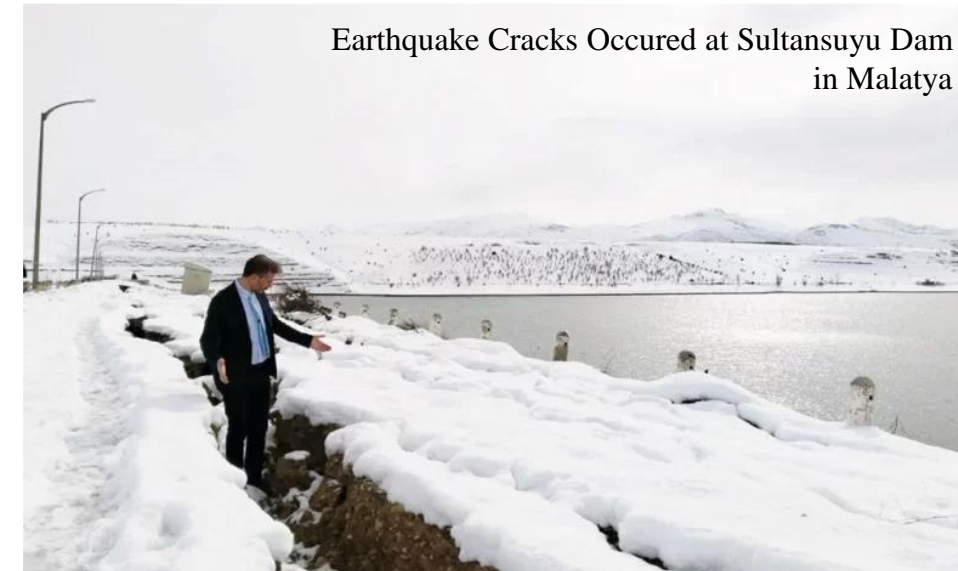
Earthquake Cracks Occured at Sultansuyu Dam in Malatya

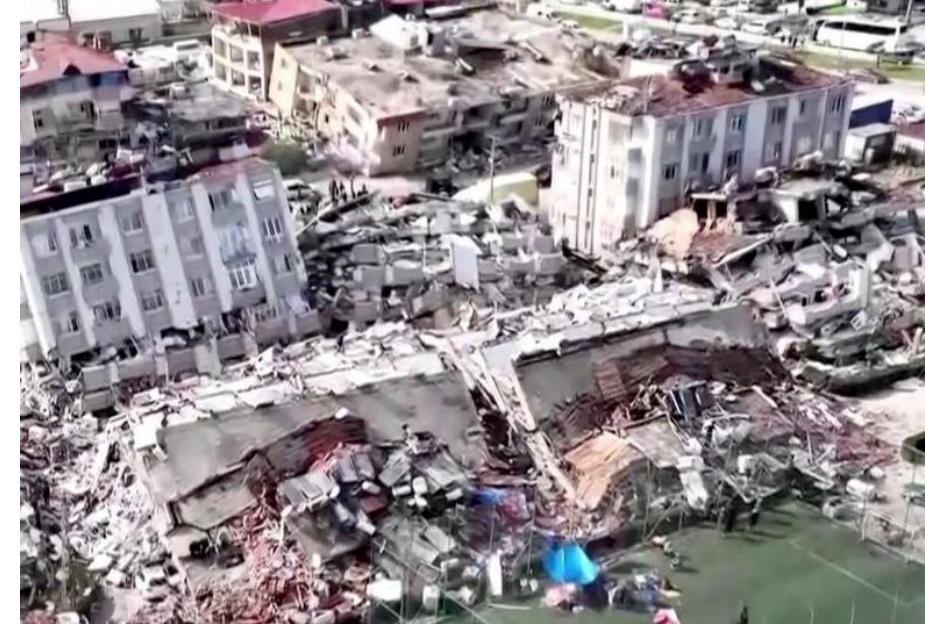
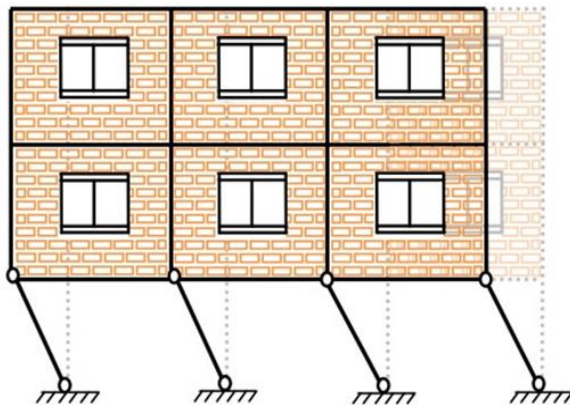
2023 Turkey/Syria earthquake

- ✓ Abrupt change in vertical stiffness lead to **vertical irregularity**
- ✓ Especially common in the ground floor since wide open are occupied for accommodating commercial or parking space

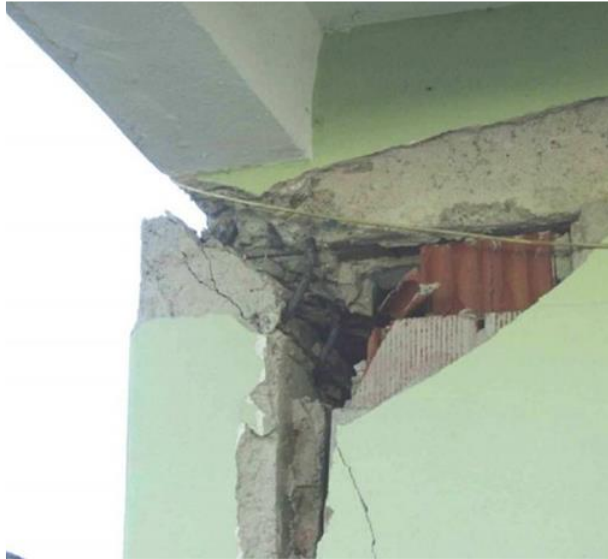
- ✓ Force transfer path **totally different**
- ✓ Unexpected short columns are formed from confinement of **partial storey height** masonry infill panels for functional openings
- ✓ Out of plane throw off failure

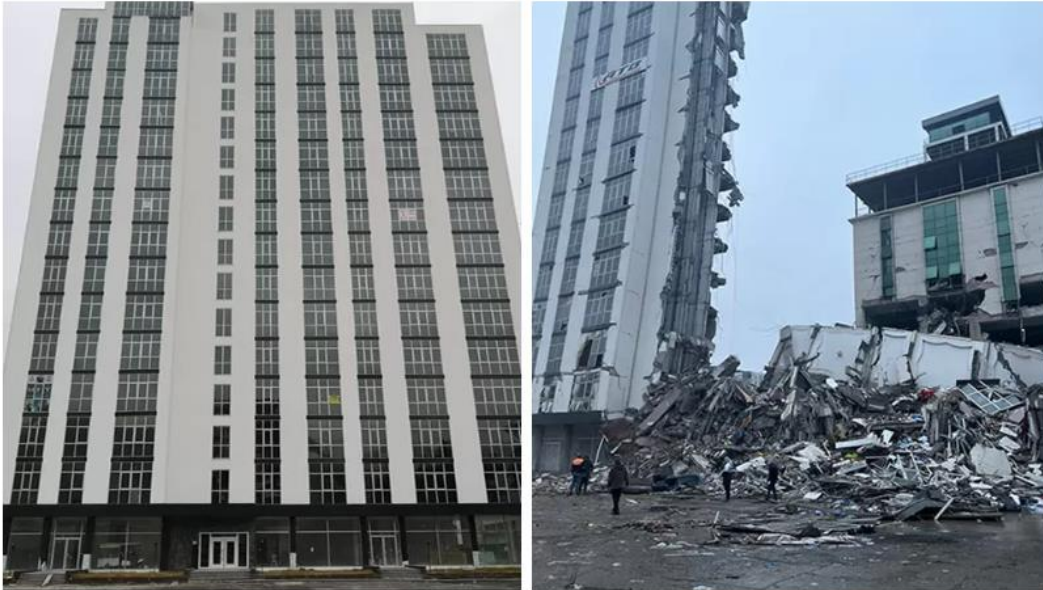
Before and after: A recently built apartment block in Iskenderun

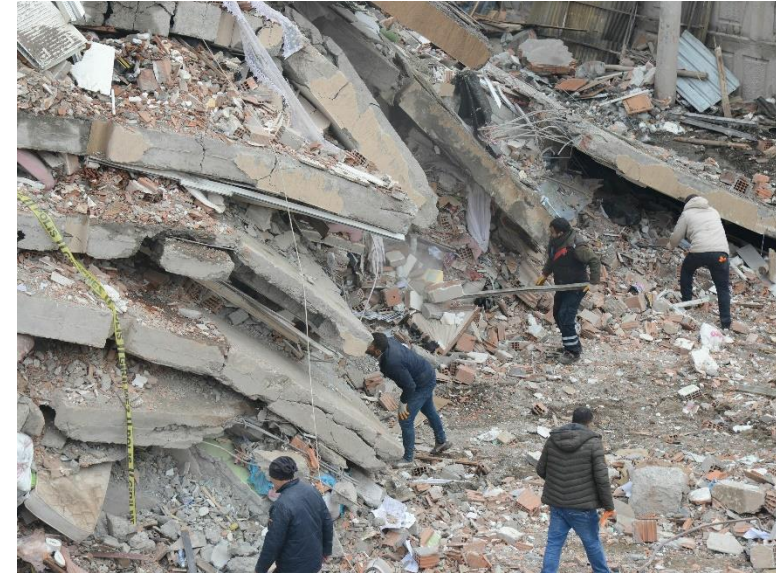
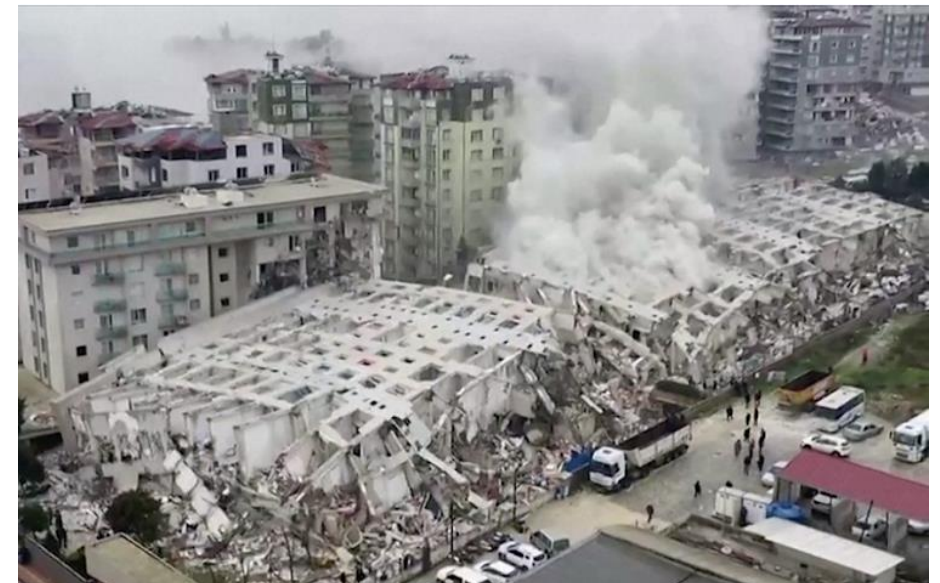
Cobblestone found in concrete, round bar not ribbed bar
Seismic design Building Regulations failure to be enforced?
